Case Study: Detecting Low- or Slow-Speed Bearing Failure with Ultrasonic Tools

Case Example: Using Ultrasound to Identify Oven Motor Bearing Failure

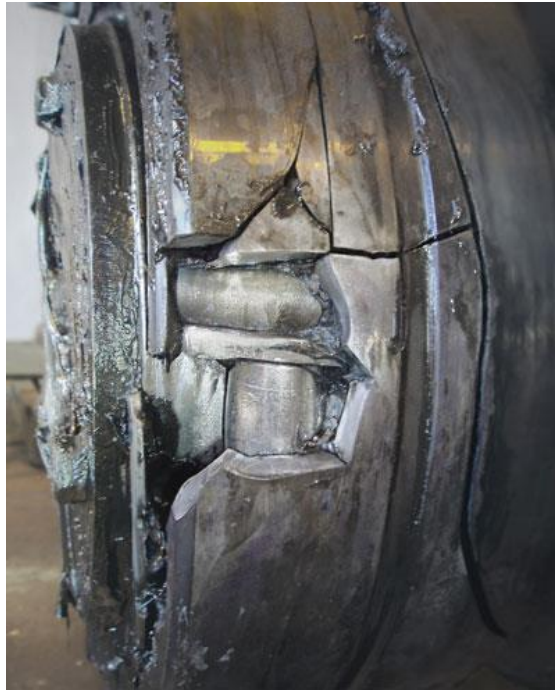
An ultrasonic instrument was used to inspect all bearings – almost all of them presented a nice and smooth sound and a 0dB reading, except for one. On one of the bearings from this set, the ultrasonic instrument was displaying 2dB instead of 0. Also, the sound heard from the headphones was different: it was not smooth as in the other bearings

and it presented a repetitive “knocking” sound. This gave the inspector an indication that something might have been wrong with this specific bearing.

Large drum oven bearing with a crack detected using ultrasonic tools

After the results from the ultrasonic inspection, a grease sample was taken to confirm if there was any damage on the bearing – in which case the grease sample would show metal contamination. The results from the grease analysis showed indeed the presence of metal particles, confirming the damage as indicated by the ultrasound instrument.

The next step was naturally scheduling an outage to replace the bearing, which was in a very bad condition as it can be seen in the images. Part of the outer race came away as it was opened. It was also noticeable that one of the rollers had moved 90 degrees. The cage had been totally damaged too.

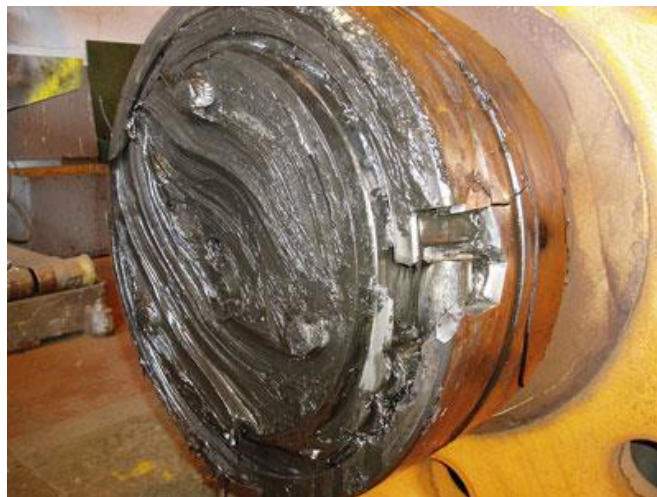
Another view of the cracked drum oven bearing

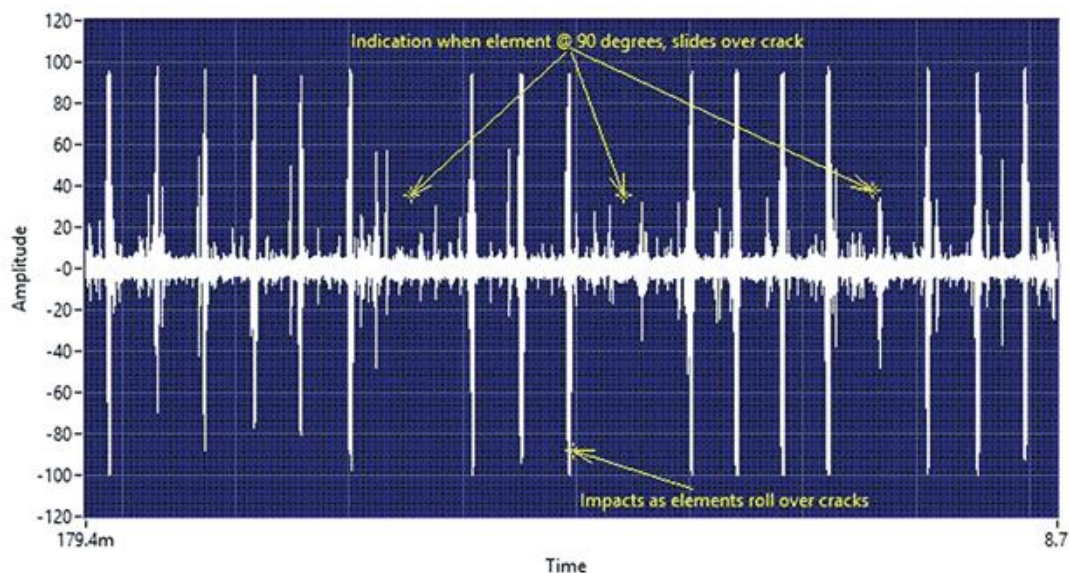
The spectrum analysis of this oven motor bearing shows clearly where the roller at 90 degrees hits the crack as the knock stops briefly. Thus, the sound pattern indicates already an existing problem, being the most reliable source of information when determining the condition of a slow-speed bearing using ultrasound.

Sound Spectrum of the damaged bearing, where the peaks in amplitude give the inspector a clear sign of damage.

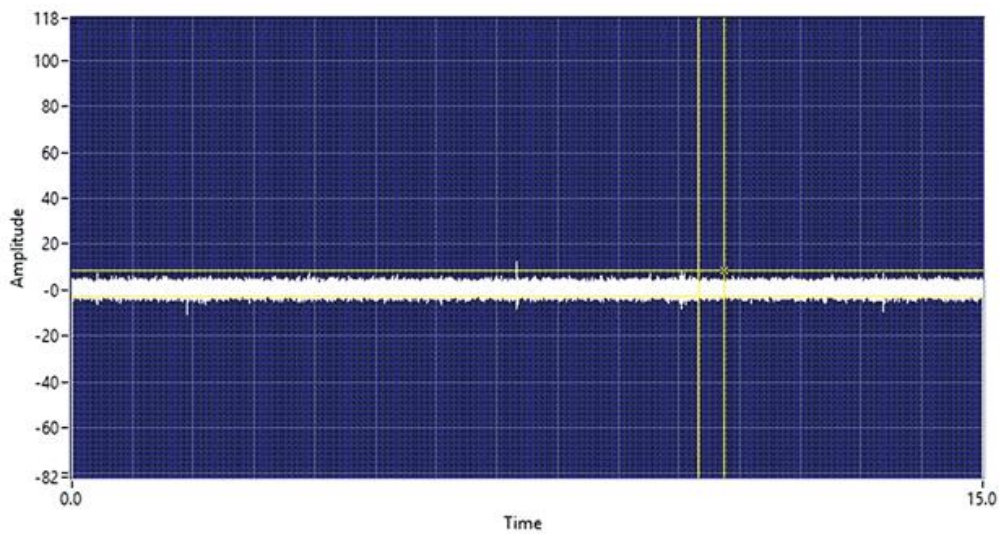
On the other hand, the spectrum of a recorded sound from one of the “good” bearings shows a very different picture: a very uniform spectrum with almost no changes in the amplitude.

Sound Spectrum of a “good” bearing. Very uniform and no changes in amplitude.
